# MICROSCOPIC EXAMINATION OF STEEL

HENRY FAY, Ph. D., D. Sc.

*Professor of Analytical Chemistry, Massachusetts Institute of Technology  
Consulting Metallurgist, Watertown Arsenal*

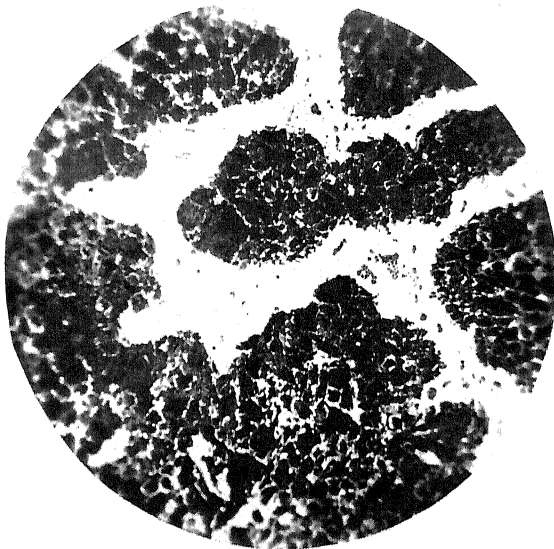
PHOTOGRAPH NO. 48. X50.

Fourteen-inch gun lever. Segregated ferrite (white) with slag inclusions.

In the fractured ends of the test pieces the metal shows decidedly bright spots, and these are due, it is believed, to the presence of the segregated ferrite. Further, it has been noticed that along the stem of the test pieces incipient cracks are developed, as shown in photograph No. 45. It is highly probable that these incipient fractures are developed in such areas as shown in photograph No. 47, which shows a large ferrite field at the edge of the specimen. It is possible that if the forces are transmitted equally throughout the test piece that such a portion would yield more readily where the carbon was lowest. The strength of such a spot would be approximately that of pure iron, or about 40,000 pounds per square inch, while the darker areas which contain more carbon would show considerably higher values. The presence of much slag in the ferrite areas would also increase the brittleness at this point, and would account for the low ductility in some specimens. Further examples of this form of segregation are shown in photographs Nos. 48 and 49.

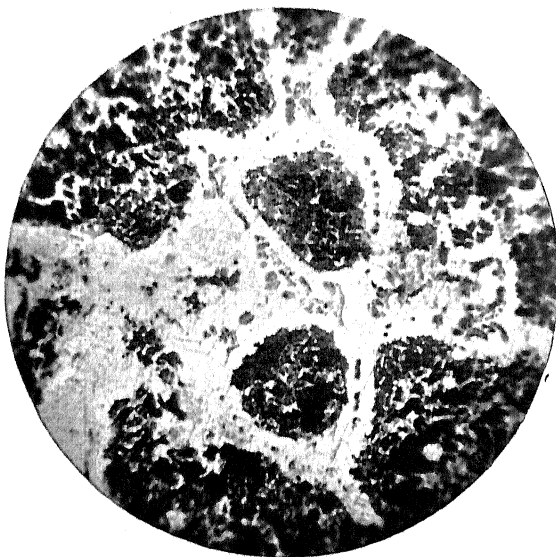
PHOTOGRAPH NO. 49. X50.

Fourteen-inch gun lever. Segregated ferrite with slag inclusions.

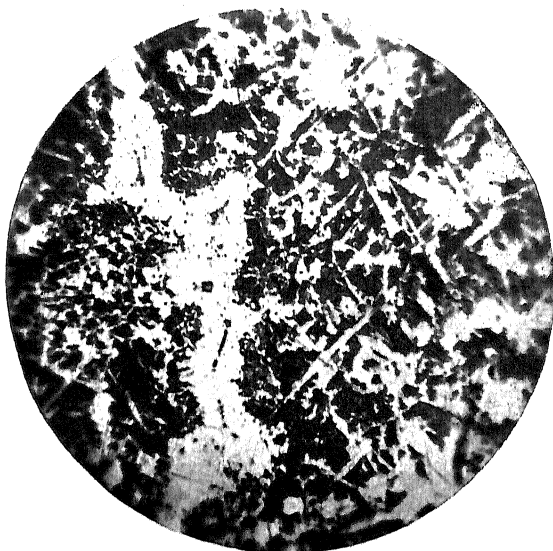
PHOTOGRAPH NO. 50. X50.

Fourteen-inch gun lever. Segregated ferrite and crystalline structure.

The metal has not been annealed in such a way as to remove the original crystallization which took place at the time of solidification. The crystalline structure is shown in photographs Nos. 50 and 51. Proper annealing should have completely wiped out all appearance of this kind. Evidence of this crystalline nature was found in all specimens examined, and it is highly

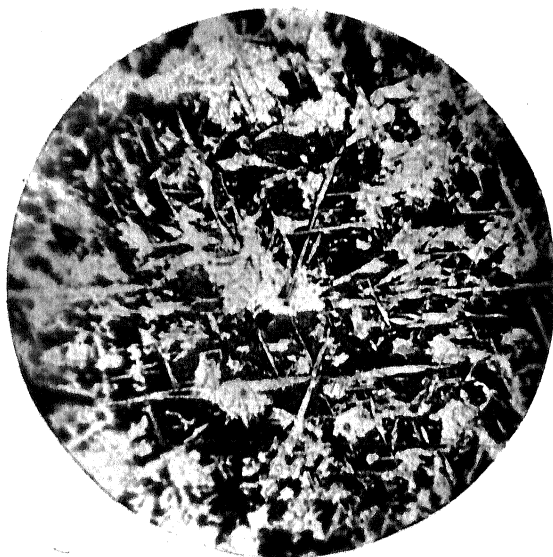
PHOTOGRAPH NO. 51. X50.

Fourteen-inch gun lever. Crystalline structure.

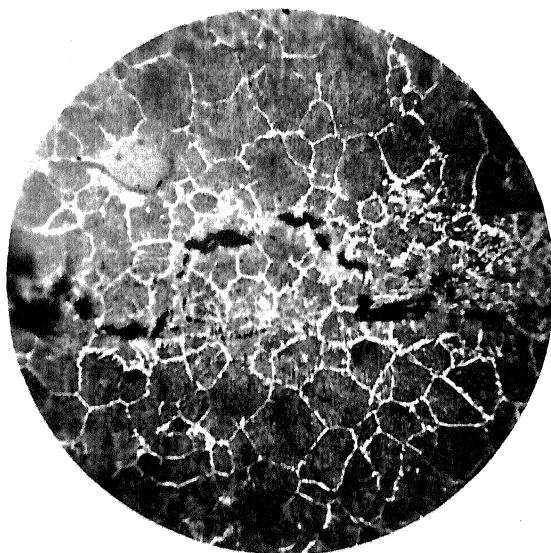
PHOTOGRAPH NO. 53. X50.

Twelve-inch gun. Microstructure showing slag and fissures.

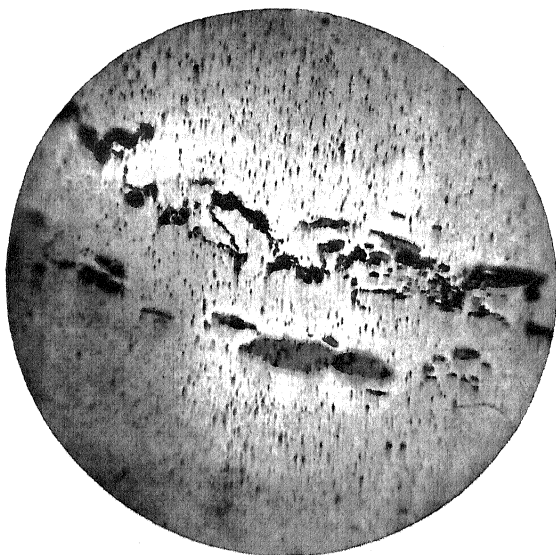
PHOTOGRAPH NO. 54. X50.

Twelve-inch gun. Slag in unetched specimen.

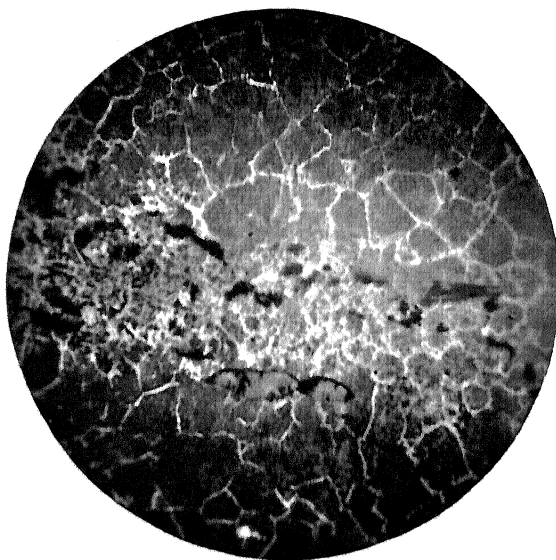
PHOTOGRAPH NO. 55. X50.

Twelve-inch gun. Same area as No. 54, etched with alcoholic nitric acid.
